Merrymeeting Watershed Dams

SUMMARY OF FINDINGS

Corey Clark – NHDES Dam Bureau

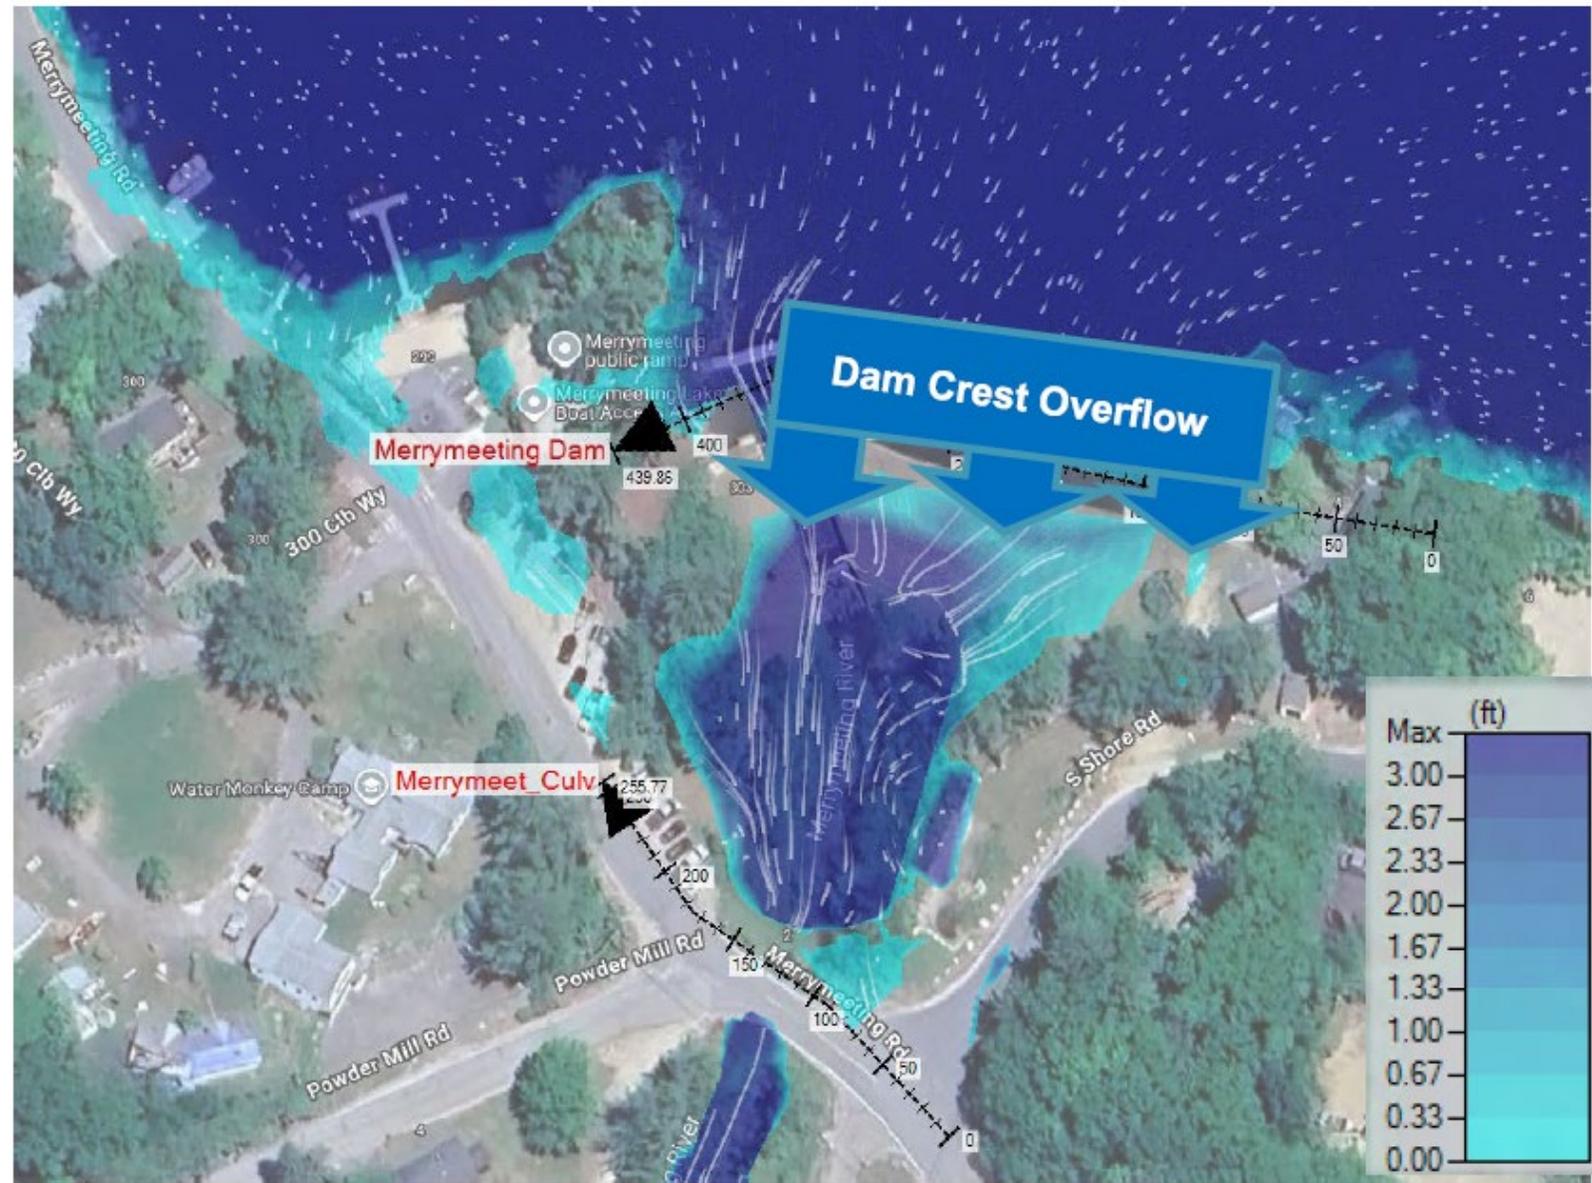
Figure 2-2: Merrymeeting Dam Overtopping Flow During 1000-Year Design Event.

Merrymeeting Dam

- Inadequate spillway capacity (0.6 ft overtopping, 24 hrs)
- Spillway founded on fill
- Aged low-level outlet pipe

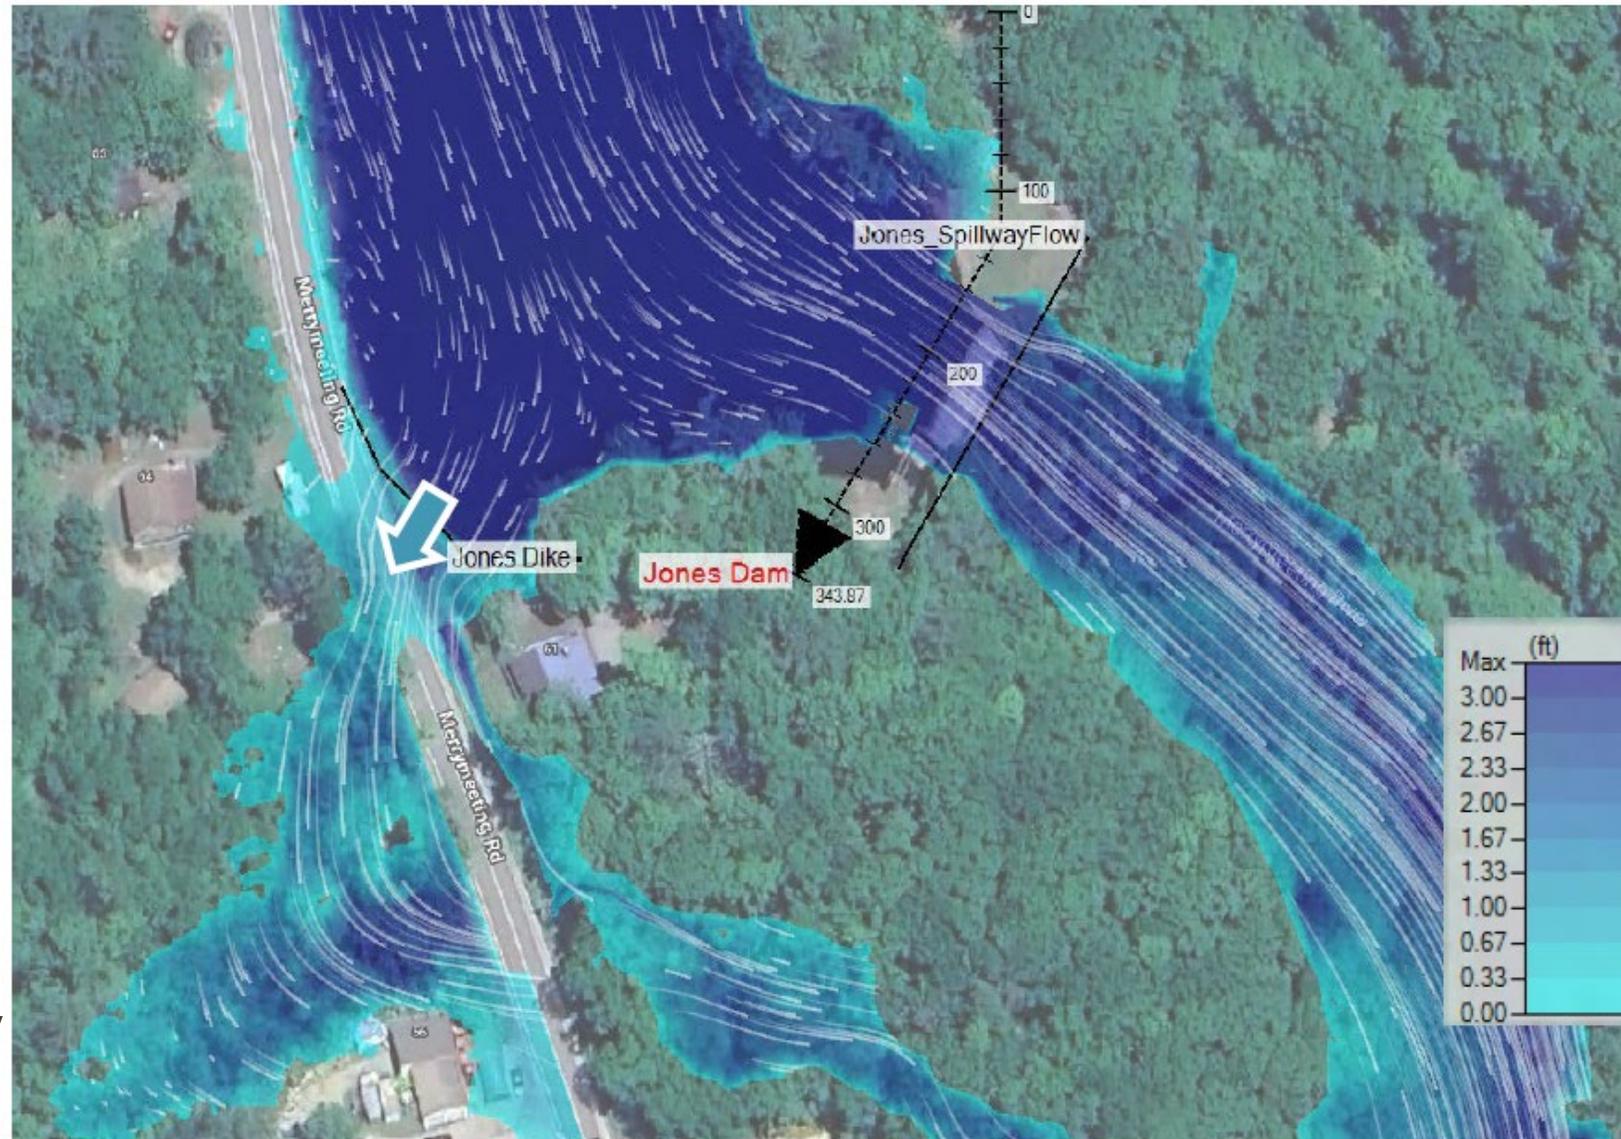
Figure 2-3: Jones Dam Overtopping Flow During 1000-Year Design Event.

Jones Dam

- Inadequate spillway capacity (1.3 ft overtopping, 9 hrs)
- Fails slope stability (both sides)
- Fails gravity stability (especially with flashboards)
- Fails all three: hydraulic, slope, gravity

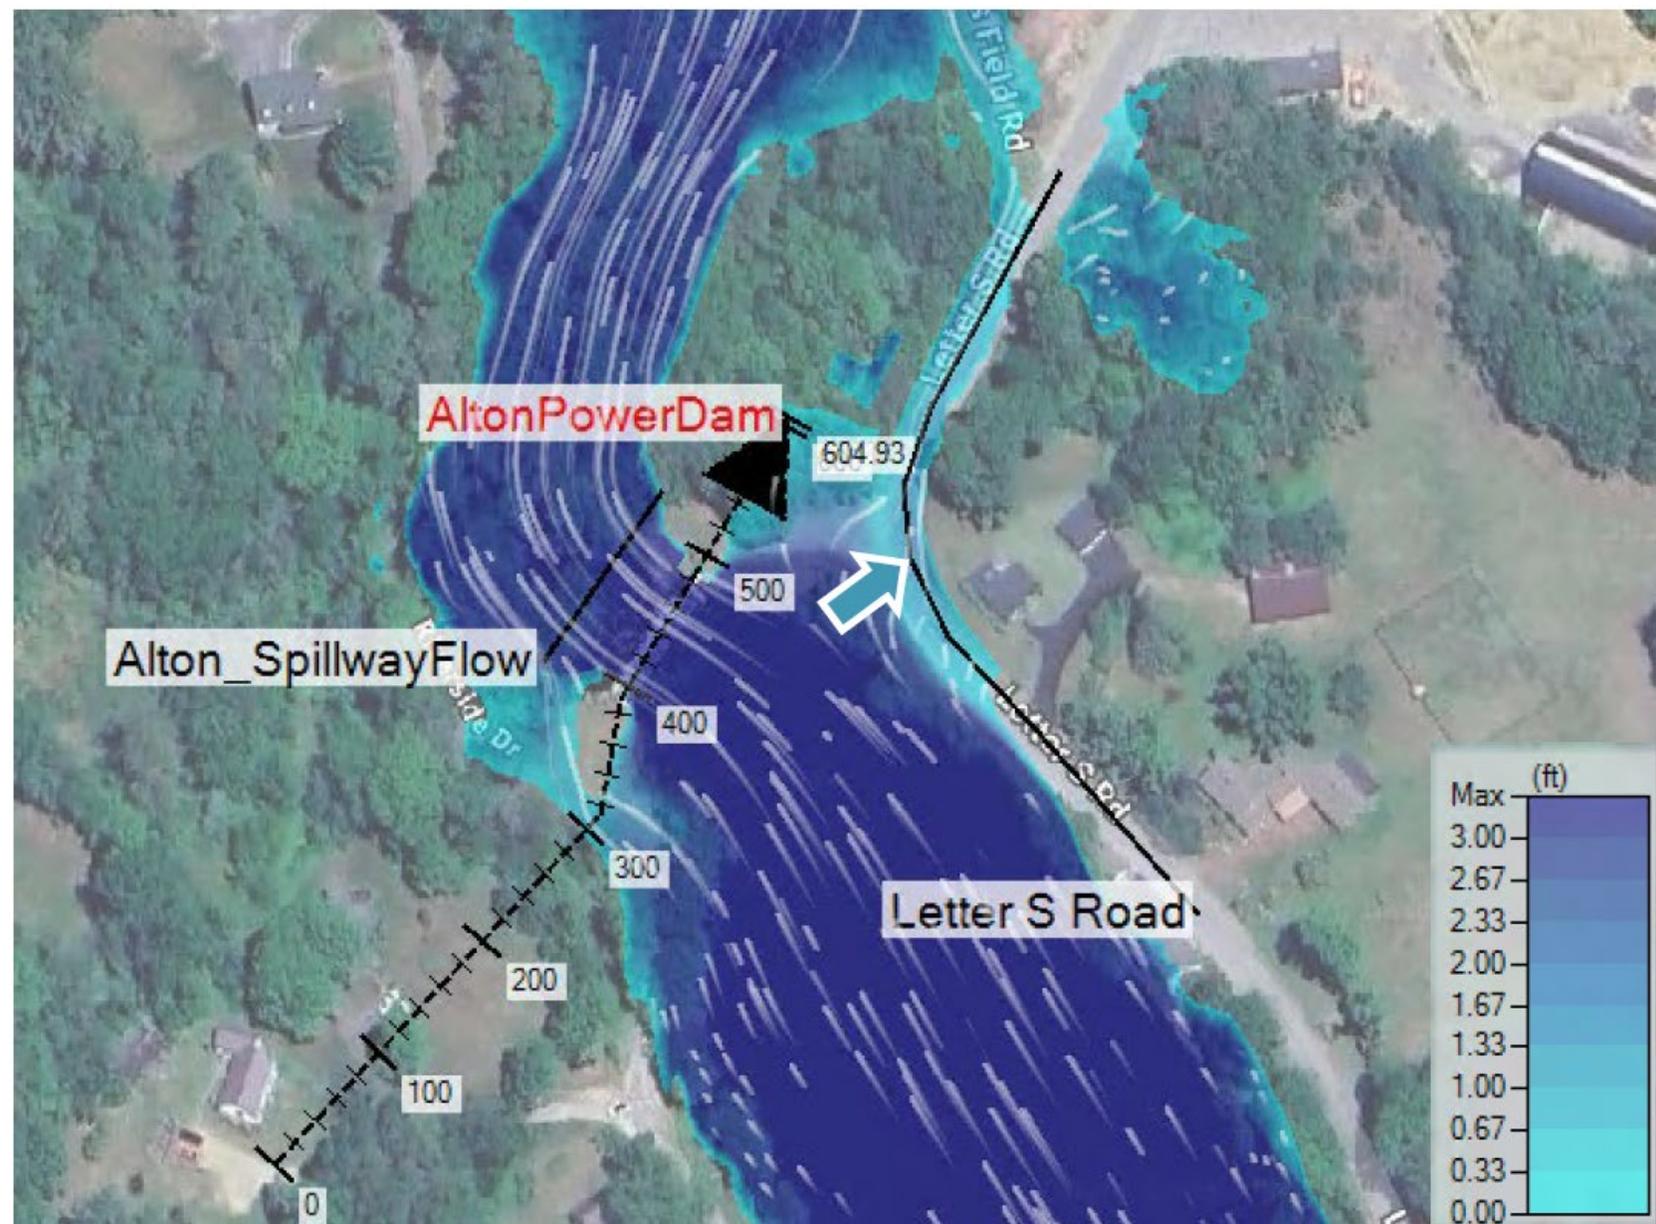
Figure 2-4: Alton Power Dam Overtopping Flow During 1000-Year Design Event.

Alton Power Dam

- Inadequate spillway capacity (1.8 ft overtopping, 56.5 hrs)
- Fails gravity stability
