Merrymeeting Watershed Dams

SUMMARY OF FINDINGS

Corey Clark – NHDES Dam Bureau

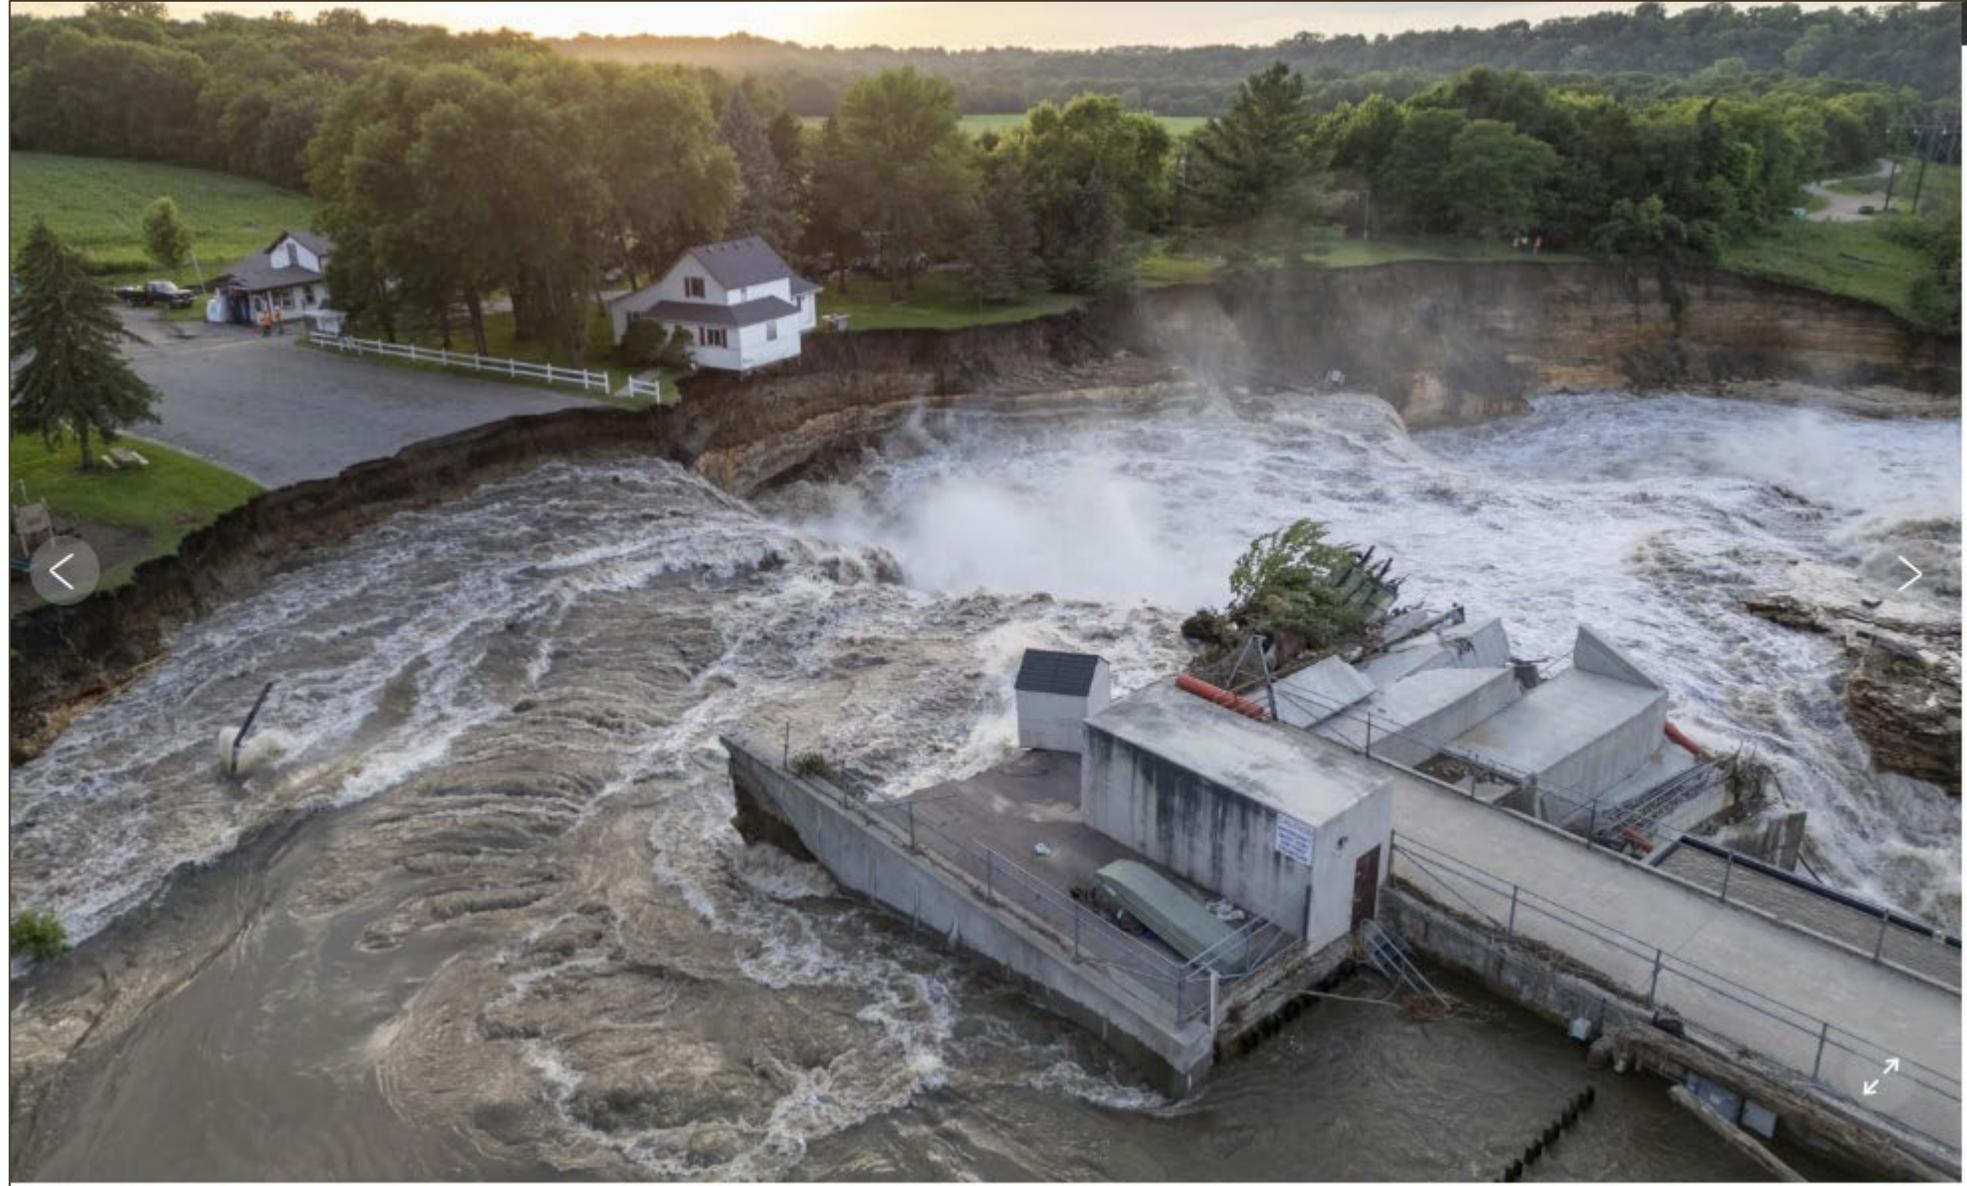
June 2024 – Rapidan Dam - Minnesota

4 of 20 | This drone photo provided by AW Aerial shows a home as it teeters before partially collapsing into the Blue Earth River at the Rapidan Dam in Rapidan, Minn., Tuesday, June 25, 2024. (Andrew Weinzierl/AW Aerial via AP)

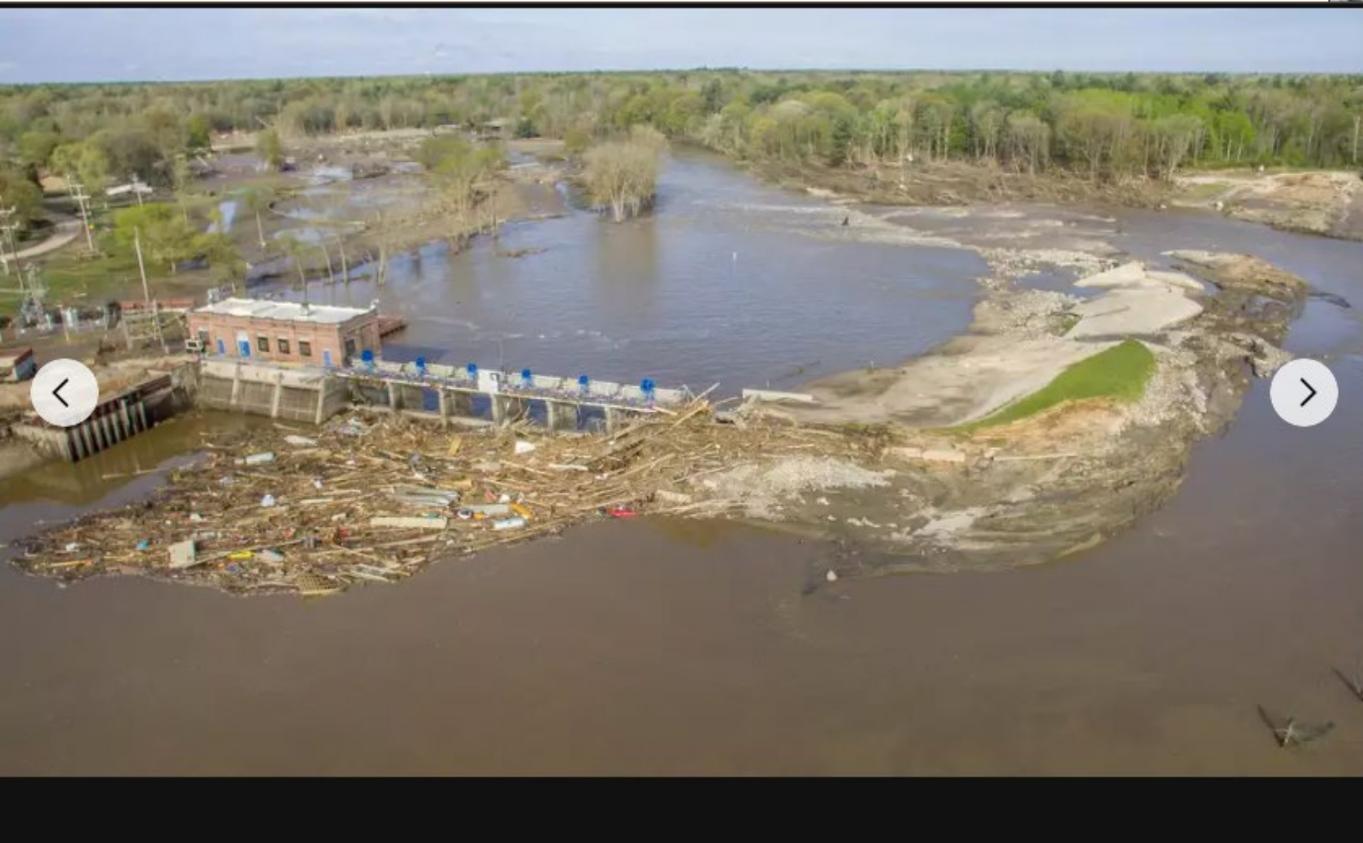
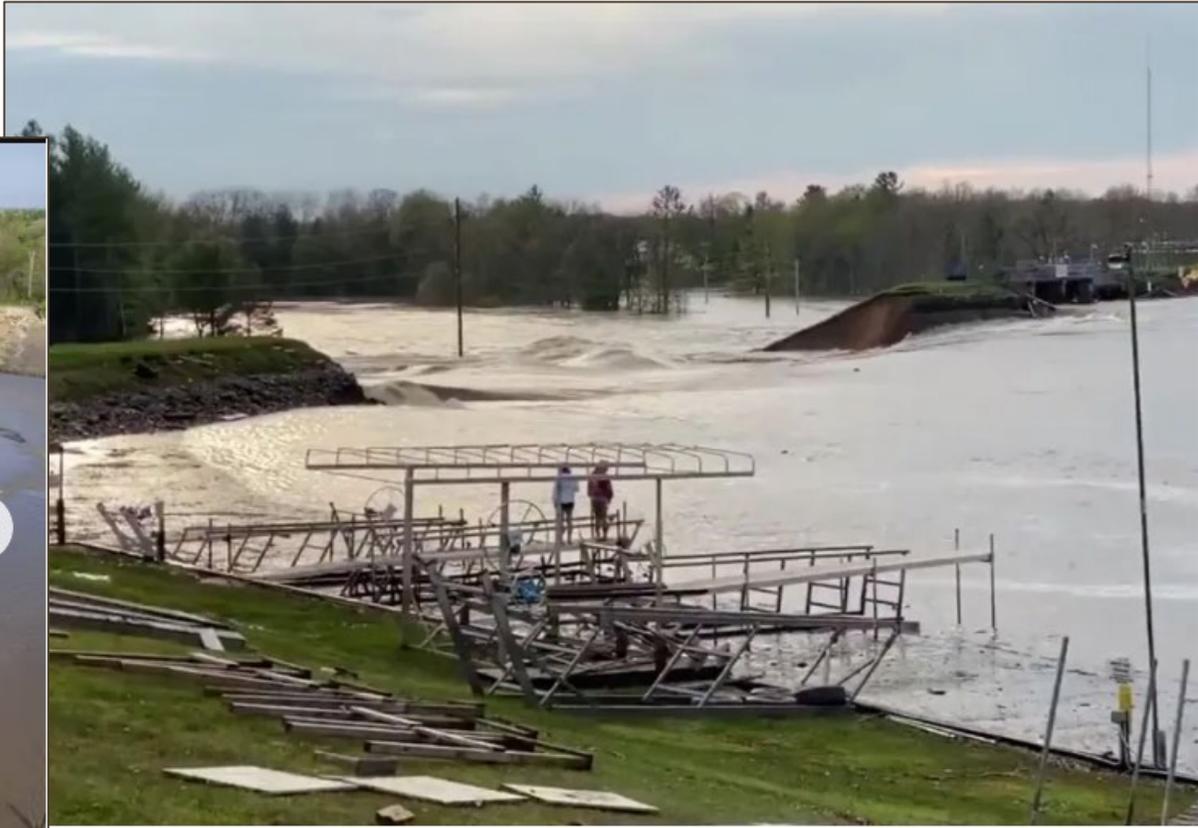
May 2020 – Edenville and Sanford Dams Michigan

The dam's failure came after days of heavy rain. Courtesy @CRichnak

An aerial photo from Friday, May 22 shows the aftermath of flooding at the Sanford Dam in Midland County.
Adam Ferman/For the Daily News

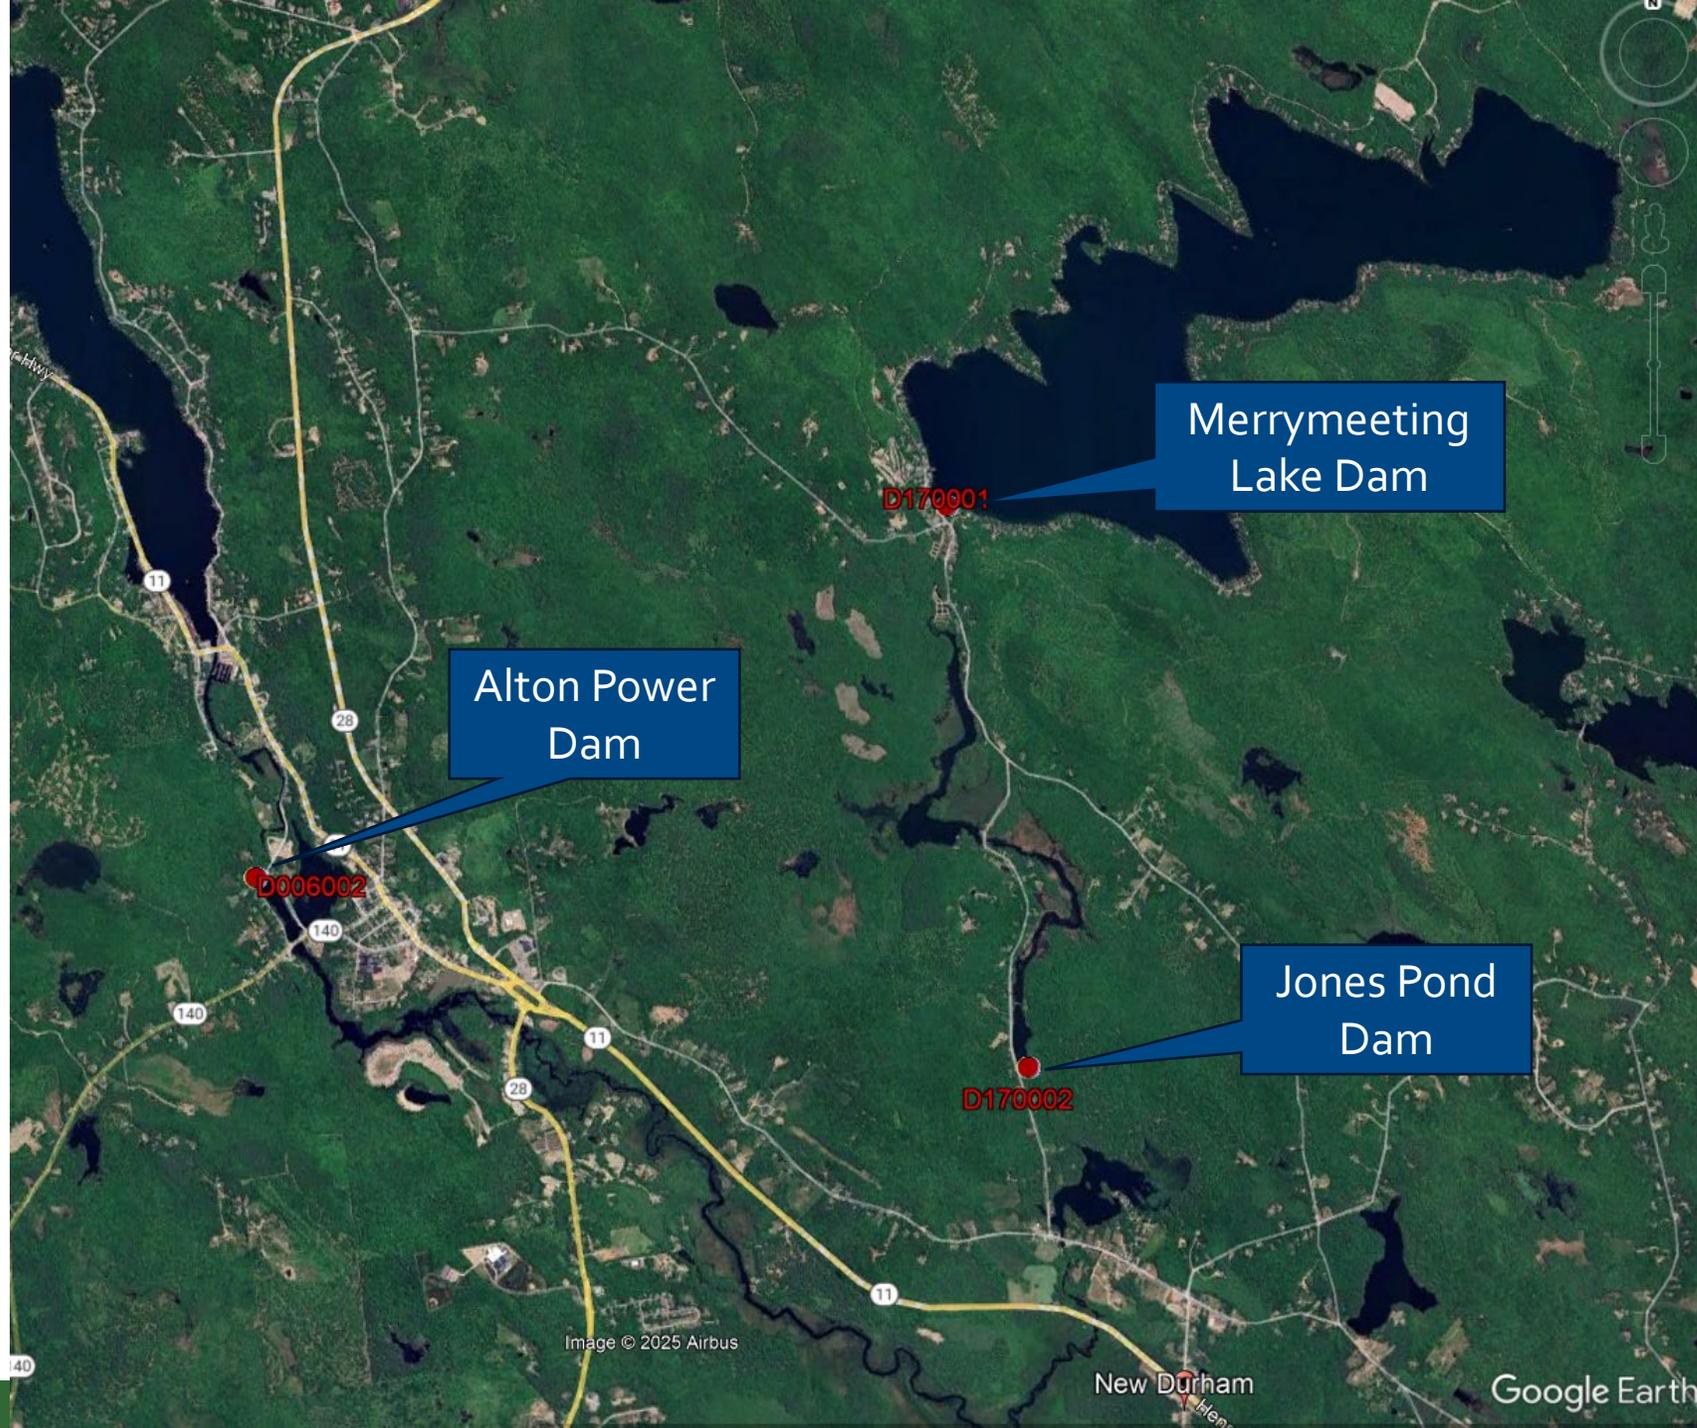
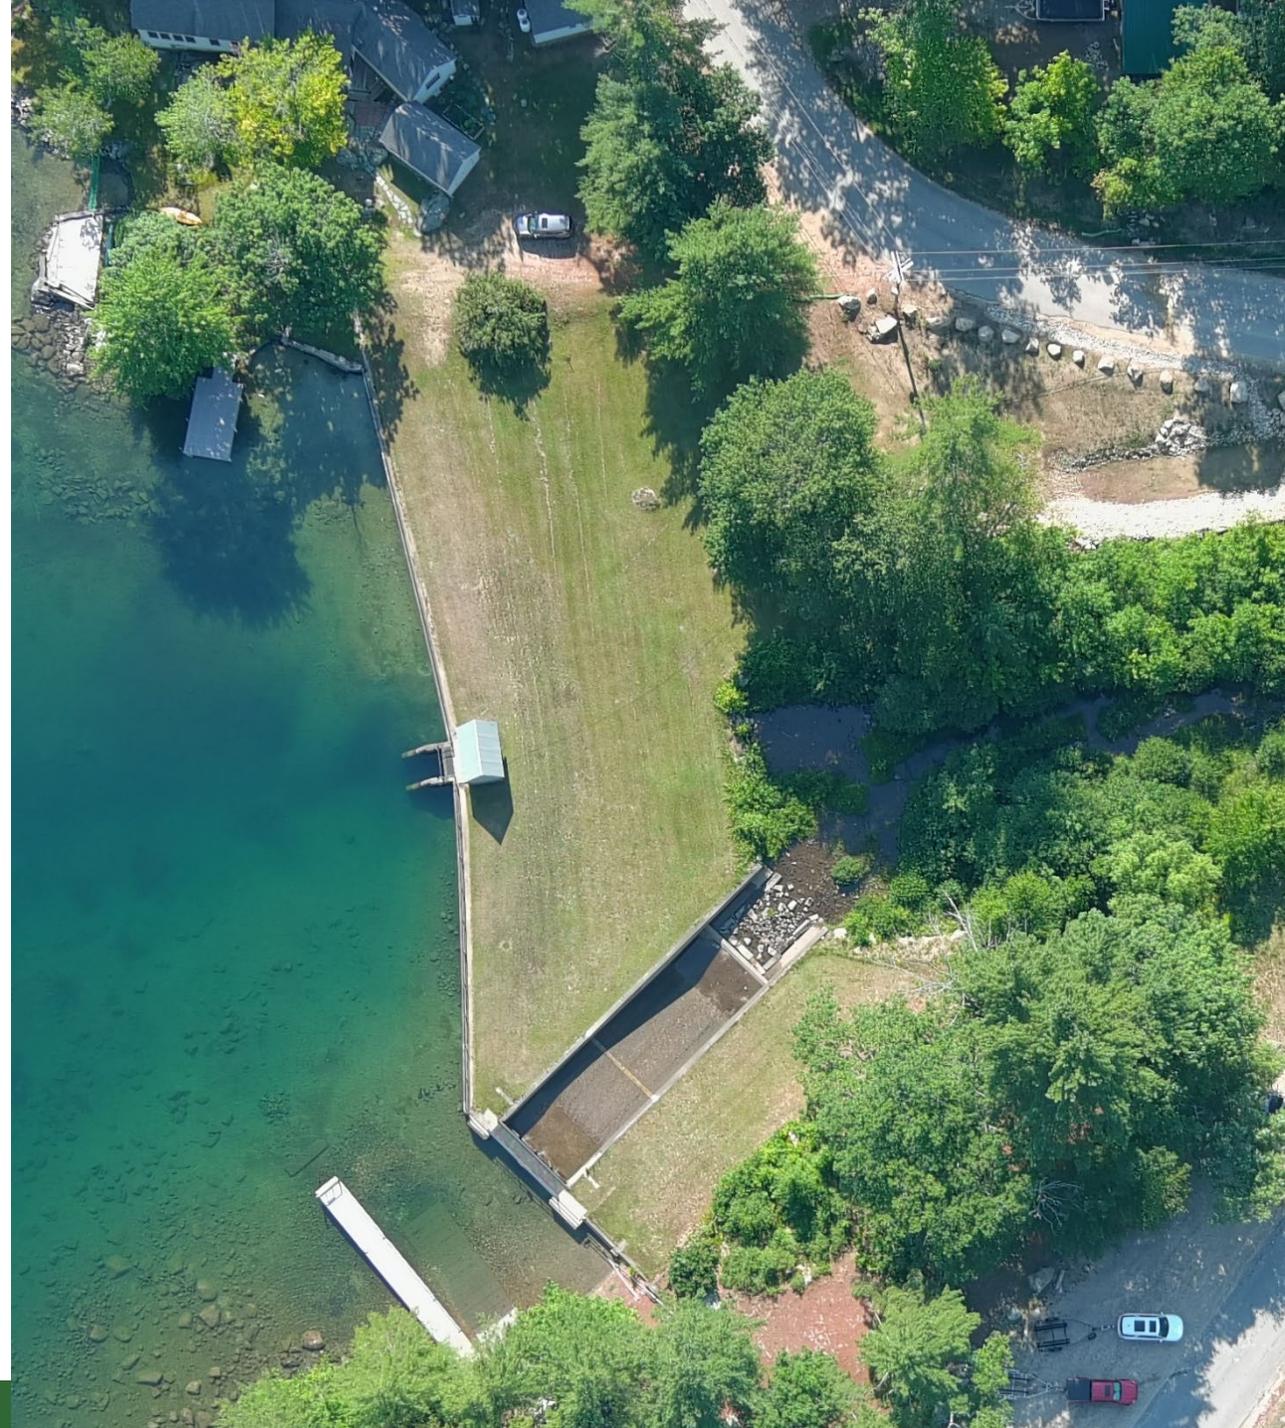
Merrymeeting Lake Dam

- Owner/Operator:
 - NH Fish and Game Department
 - NHDES Dam Bureau
- Hazard Classification: High
- Condition Rating: Poor
- Total Length: 285 ft
 - Spillway Length: 22 ft
- Maximum Height: 22 ft
- Purpose: Recreation
- Constructed in 1924
 - Reconstructed in 1969, and 1983

- Inadequate spillway capacity (0.6 ft overtopping, 24 hrs)
- Spillway founded on fill
- Aged low-level outlet pipe

- Alternative M2—Spillway Replacement

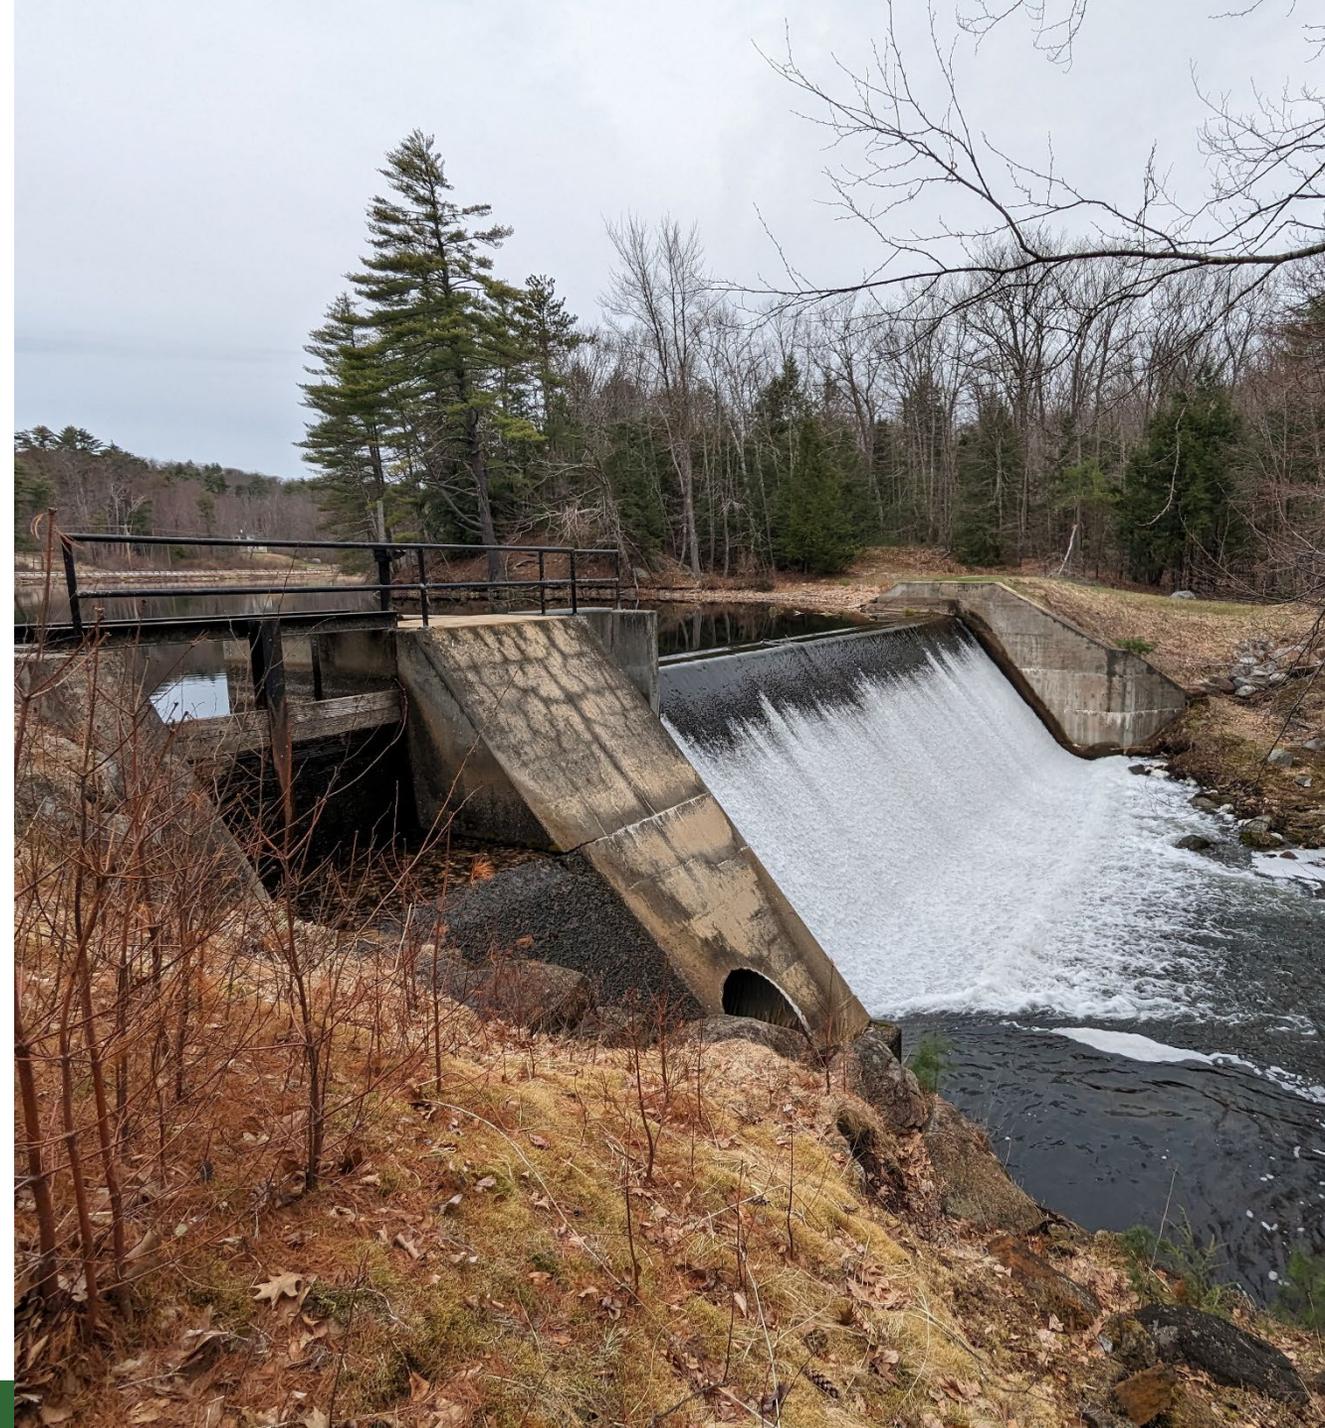
Jones Dam

- Owner/Operator:
 - NH Fish and Game Department
 - NHDES Dam Bureau
- Hazard Classification: High
- Condition: Poor
- Total Length: 210 ft
 - Spillway Length: 66 ft
- Maximum Height: 21 ft
- Purpose: Recreation
- Constructed in 1924
 - Reconstructed in 1986

- Inadequate spillway capacity (1.3 ft overtopping, 9 hrs)
- Fails slope stability (both sides)
- Fails gravity stability (especially with flashboards)
- Fails all three: hydraulic, slope, gravity
